## No. 0403-BSc

## **Critical Detail Checklist for Wall Assemblies**

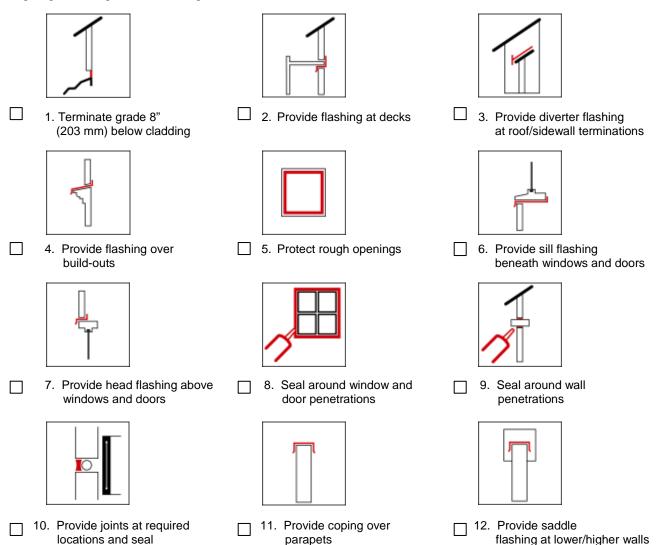
Water intrusion into wall assemblies has become a growing concern in the construction industry, yet water intrusion can be prevented simply by following sound construction practices that are required by model building codes. The list of details below illustrates some of the key areas of construction to pay attention to when designing, detailing or constructing walls.

It has been said that, "As much as 90 percent of all water intrusion problems occur within 1 percent of the total building exterior surface area. The 1 percent of the structure's façade contains the terminations and transition detailing that all too frequently lead to envelope failures." <sup>1</sup> By paying close attention to construction details at cladding terminations, water intrusion can be prevented and building durability enhanced.
